THE ARCHAEOLOGY OF KENILWORTH CASTLE'S ELIZABETHAN GARDEN

EXCAVATION AND INVESTIGATION
2004–2008

**Brian Dix
Stephen Parry
Claire Finn**

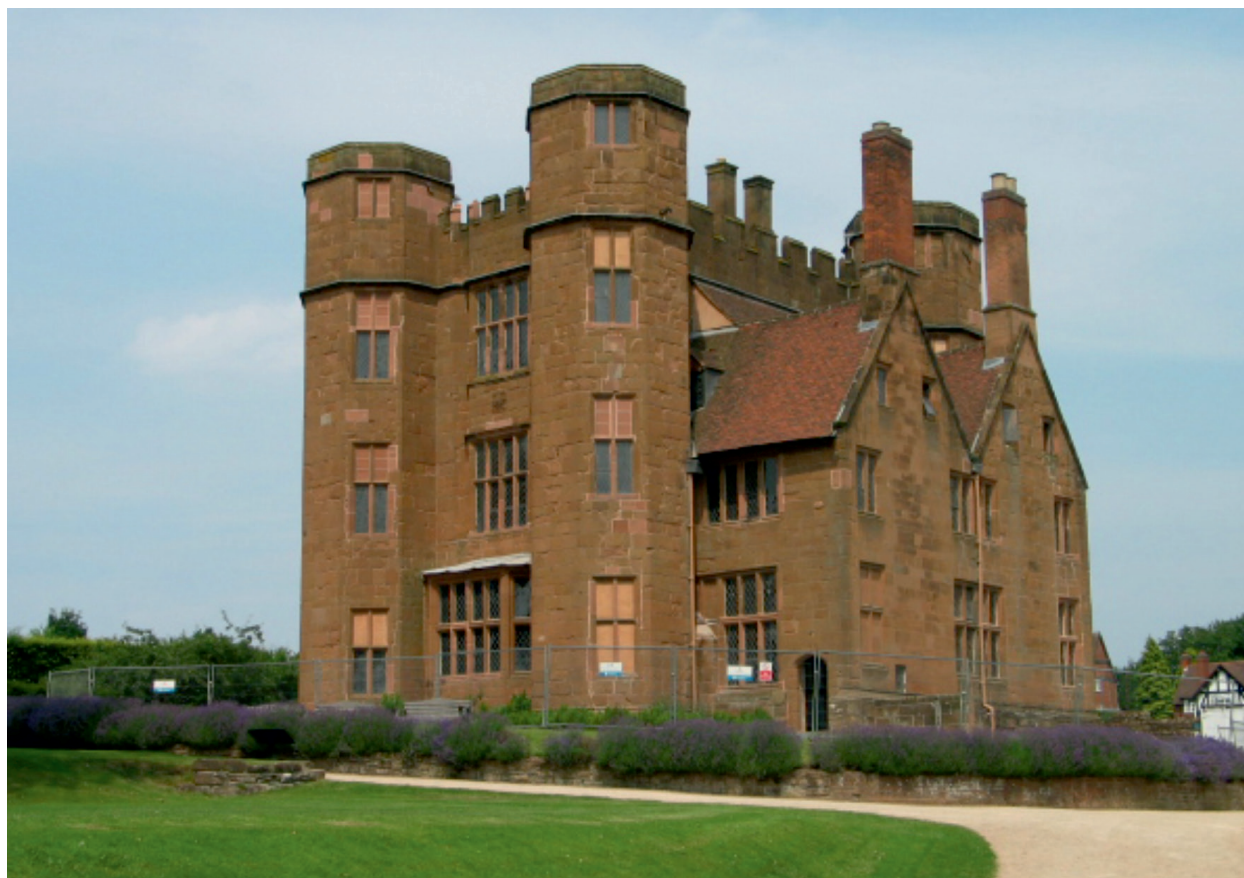
FIGURE 2.2 VIEW OF LEICESTER'S GATEHOUSE, CONVERTED TO A RESIDENCE AFTER THE CIVIL WAR, LOOKING NORTH-WEST

Major Joseph Hawkesworth, a Parliamentary commander who bought the castle, established a residence in the northern (Leicester's) gatehouse, blocking the central archway and adding a gabled range on the east side (Fig 2.2). Only the stables were retained as serviceable buildings with the remainder of the castle left to ruin. After the Restoration, short leases were granted by the Crown to the Earl of Monmouth and his family, which lasted until the early eighteenth century (Jacques and Keay 2013, 40). In 1665 the freehold had been granted to the Earls of Rochester and Clarendon, and Clarendon's son Laurence Hyde came into full possession after Monmouth's leases finally ended. The family retained ownership into the twentieth century.

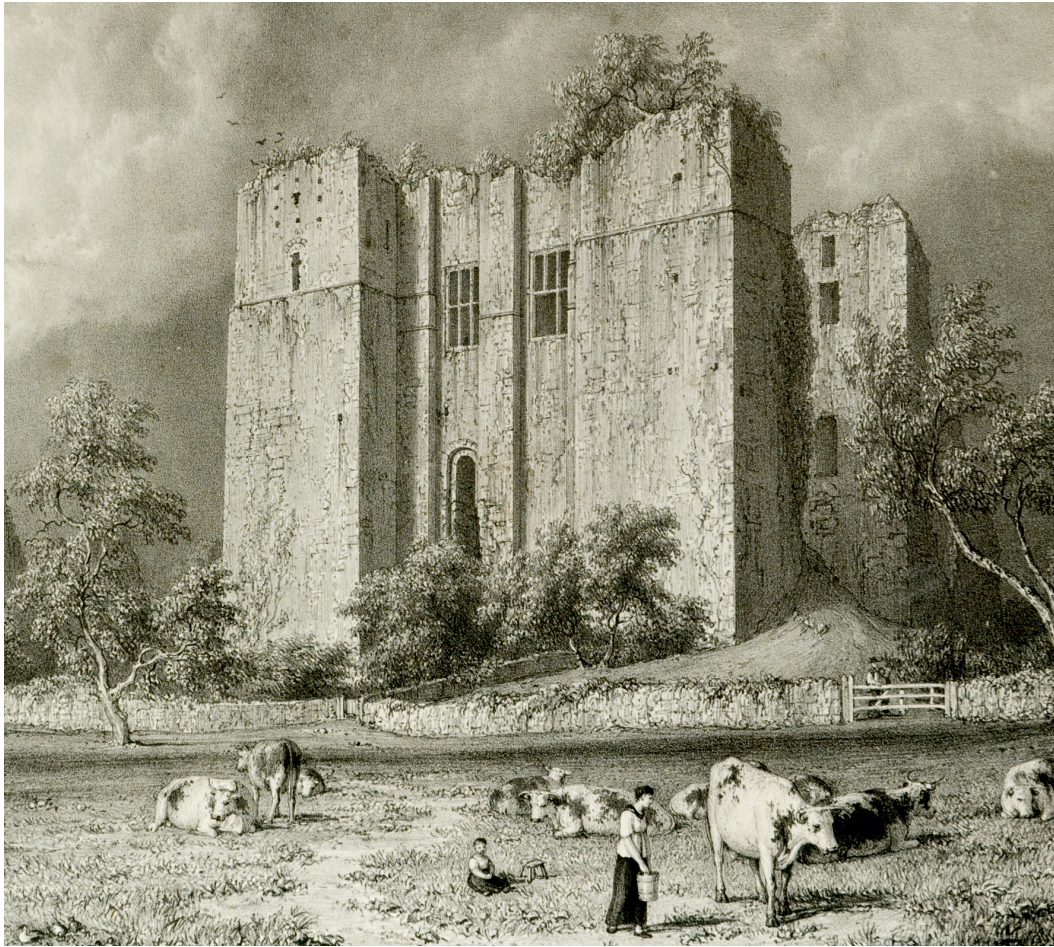
FIGURE 2.5 DETAIL OF AN UNDATED ENGRAVING, C1820, OF THE KEEP WITH SLIGHTING DEBRIS SPILLING INTO THE GARDEN AREA AT RIGHT

illustrate the area of the former Elizabethan garden. Scenes of the northern side of the castle tended to concentrate on the remains of the slighted keep and depict a great mass of rubble from its broken north wall, while the area of the garden is shown heavily wooded (Fig 2.5). Extensive repairs to the fabric of the castle were made between 1868 and 1872 and it is possible that the mound of rubble within part of the garden was cleared around this time. Early twentieth-century photographs show that the area comprised a flat garden with the terrace against the north side of the keep, and its floor largely planted with fruit trees (Fig 2.6; Jacques and Keay 2013, figs 5.4 - 5.5).

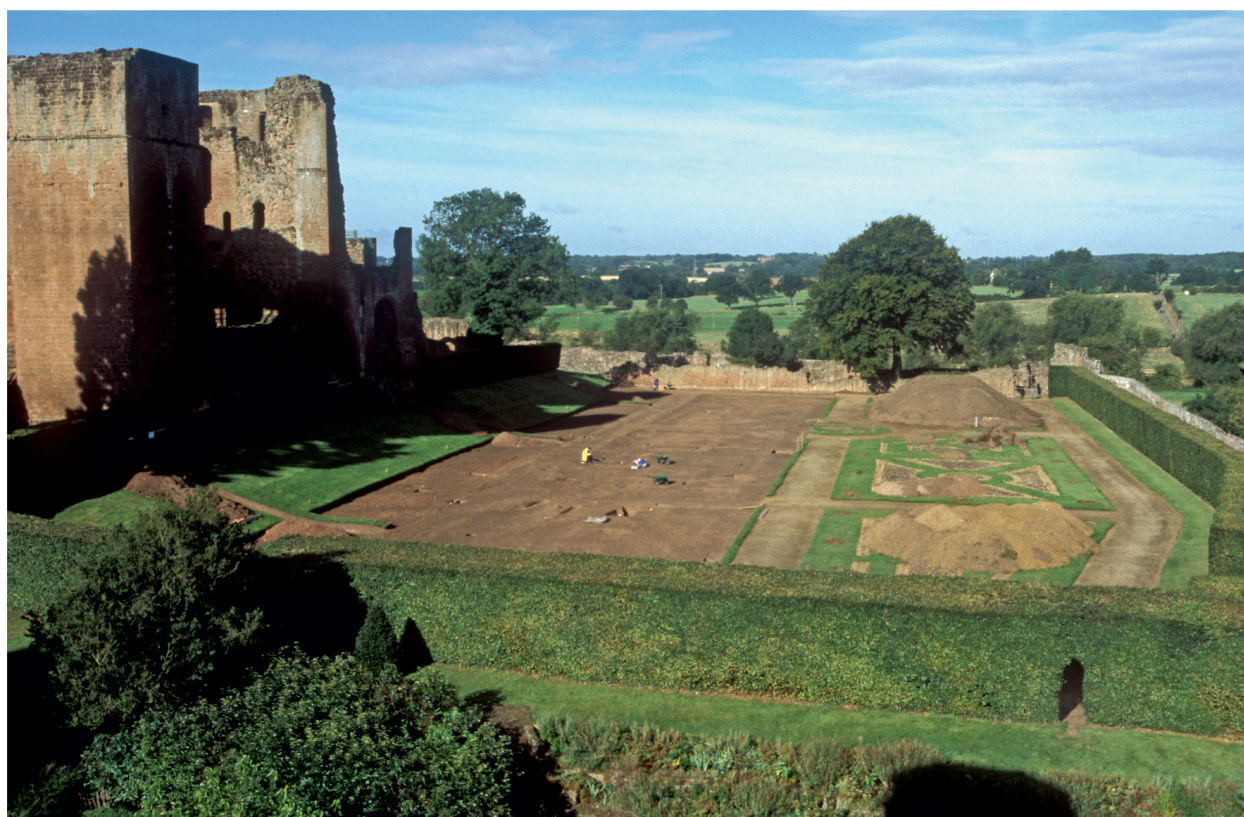
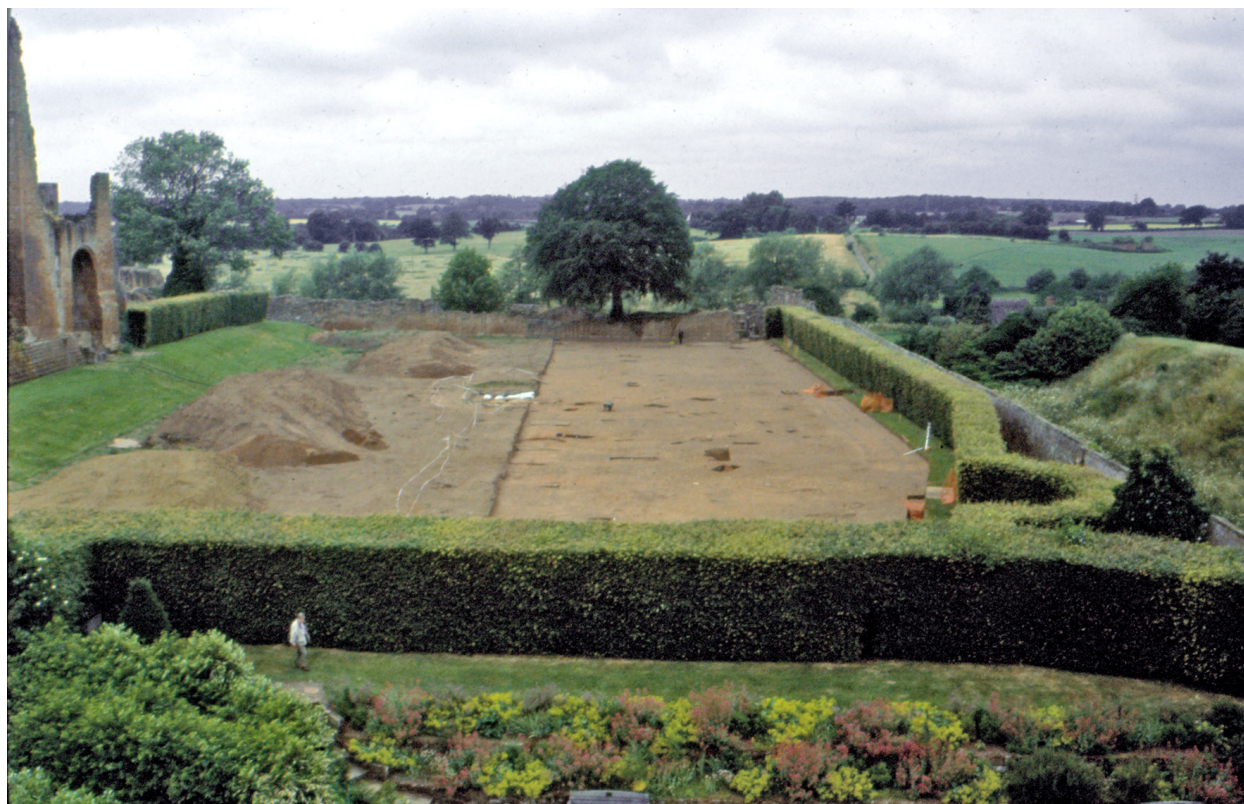
FIGURE 3.1 2005 EXCAVATION LOOKING WEST FROM THE GATEHOUSE ROOF

FIGURE 3.2 2006 EXCAVATION LOOKING WEST FROM THE GATEHOUSE ROOF

The work was spread over two seasons with the excavation of the southern half of the garden being undertaken first, followed by the area to the north (Figs 3.1 and 3.2); these excavations were designated trenches 4 and 5 respectively. This phased programme was due to the decision to retain soil on site for reuse. In each instance, modern topsoil was removed by mechanical excavator under archaeological supervision to reveal earlier layers and features, principally the levelling layers for the Elizabethan garden (Trench 5) and the Civil War ditch (Trench 4), which were then cleaned by hand. A series of smaller trenches were dug around the edges of the main work in order to investigate the boundaries of the garden; trenches 1, 2, 3, 6 and 8 examined the terrace beside the keep, together with the inner bailey and Civil War ditches. Trenches 9 and 11 were positioned to investigate the north curtain wall and towers of the outer bailey, while trenches 7 and 10 were opened to examine the eastern side of the garden (Fig 3.3). Geophysical surveys were carried out during each season by Dr Neil Linford, Archaeometry Branch of then English Heritage, but the results were inconclusive, with few distinct anomalies being detected, and none which could be identified archaeologically.

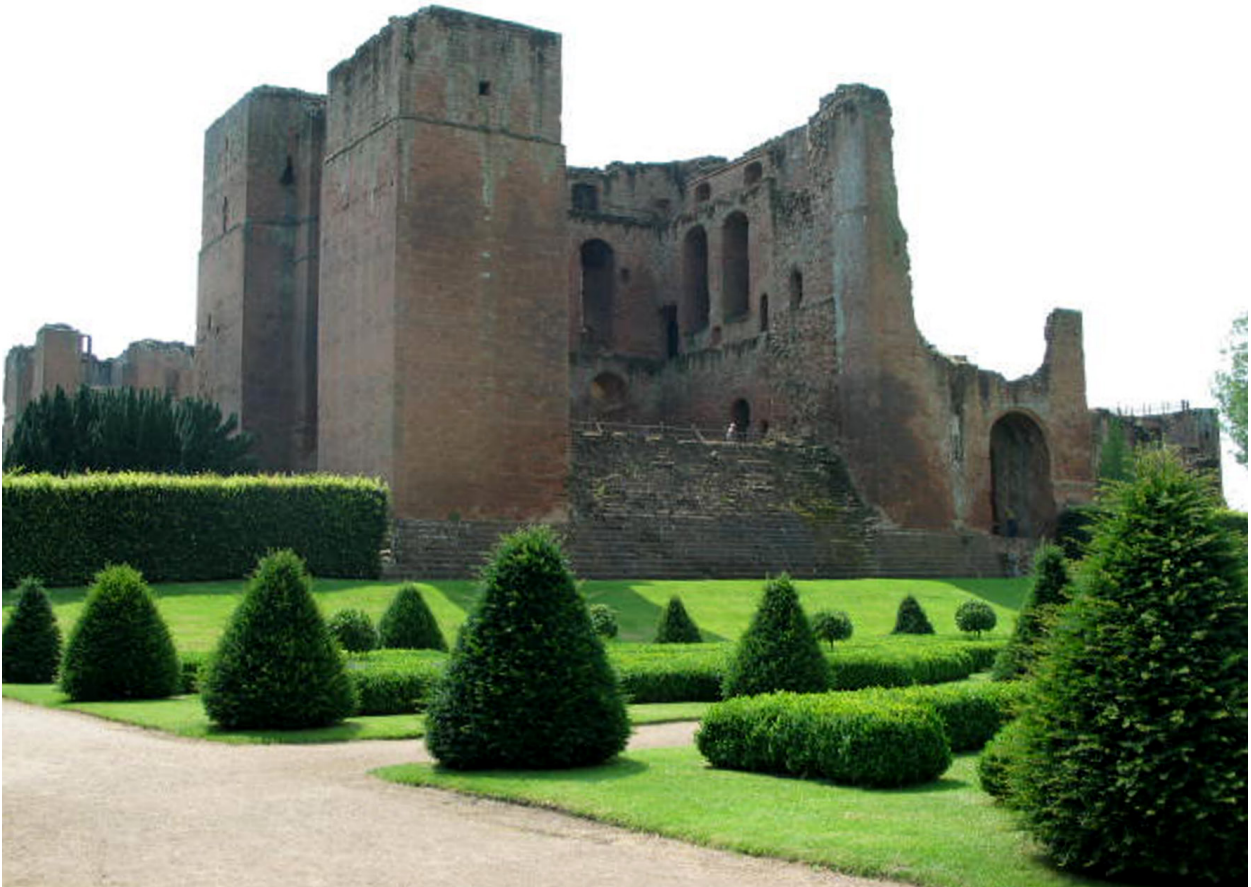
FIGURE 3.4 VIEW OF THE SLIGHTED NORTH SIDE OF THE KEEP OVERLOOKING THE 1975-GARDEN, TAKEN IN 2005.

steps onto the former terrace were also recorded since these were to be hidden by a new arrangement of timber steps providing a safer and more visually appropriate entrance into the new garden (Fig 3.4). At least part of the existing configuration of steps was identified as a modern construction.
